NASA TECHNICAL NOTE

NASA TN D-563

INVESTIGATION OF S-IV ALL SYSTEMS VEHICLE EXPLOSION

Compiled and edited by J. B. Gayle

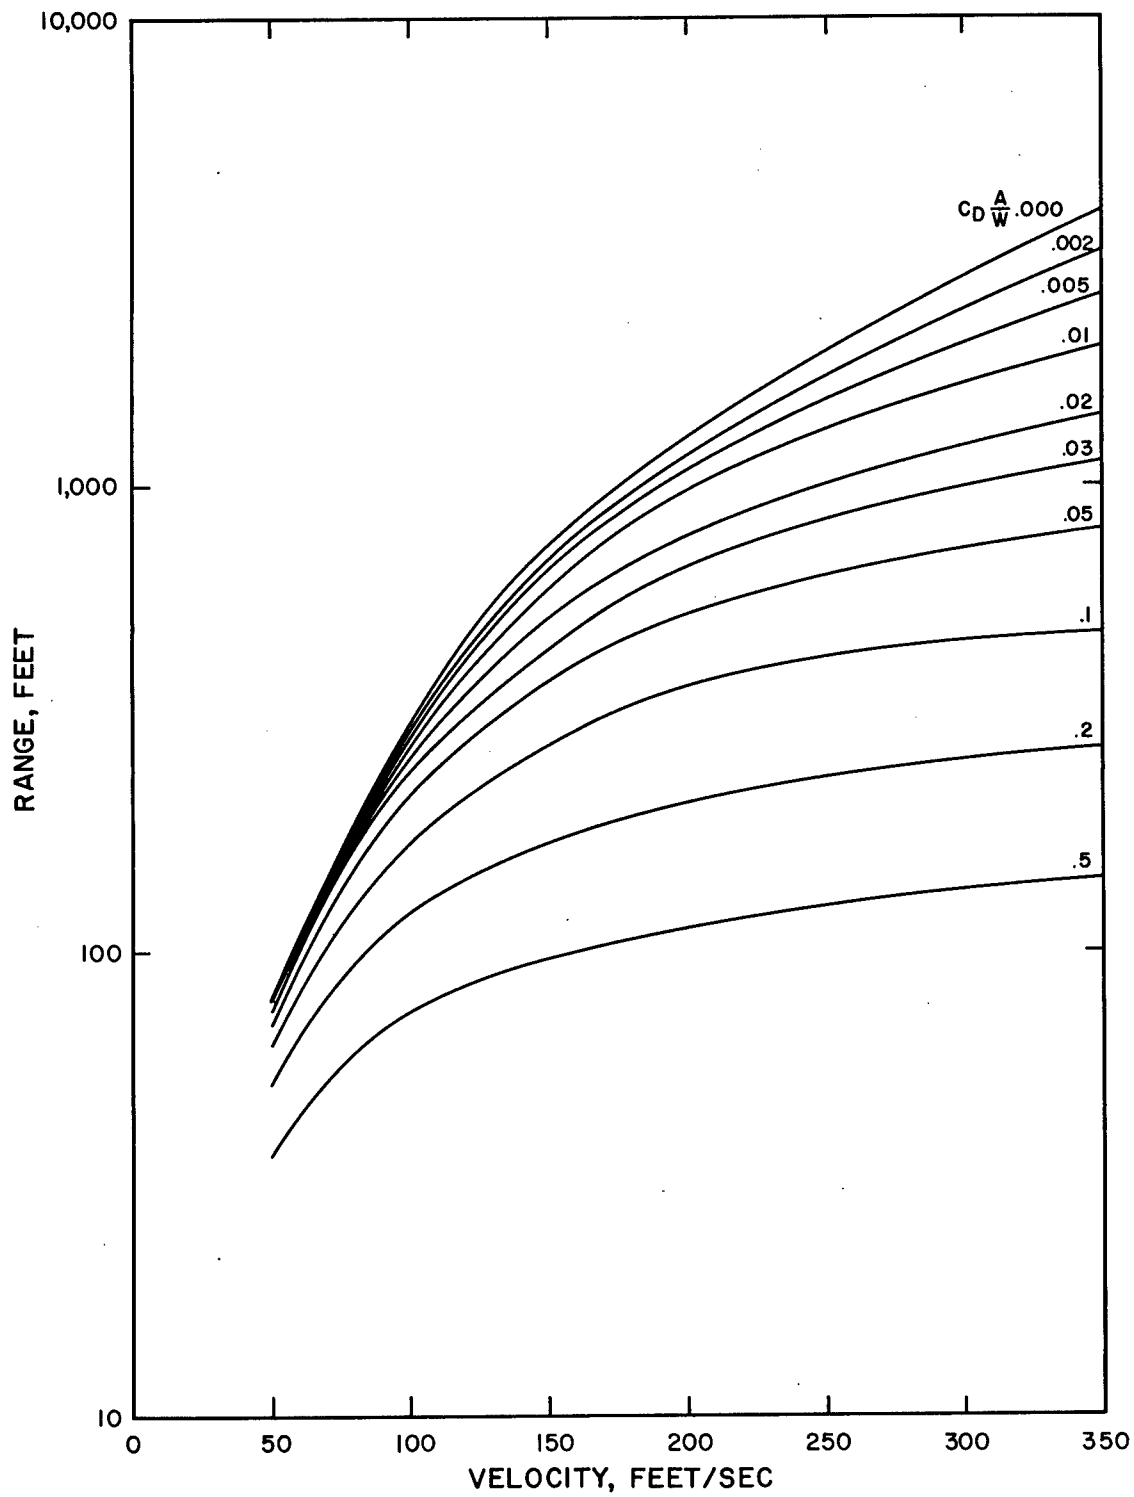
FIGURE 12. RELATION BETWEEN INITIAL VELOCITY AND GROUND RANGE
(LOW VELOCITY RANGE)

Figures 12 and 13 indicate the relation between initial velocity and distance traveled for fragments of different drag coefficients, cross sectional areas, and weights using an assumed flight angle of 45°. Table IV gives the identities and pertinent data for selected fragments from the S-IV All Systems Vehicle explosion and initial velocities estimated from FIG 12 and 13.
